Manhole Inspection Summary

Manhole # S31I2013MH

Insp Date: **12/21/06 9:12 AM**

Location Address: **6301 GITTINGS AVE**

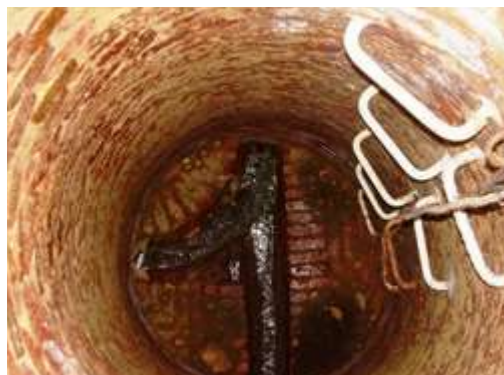
Top View

Corroded steps. Bench debris.

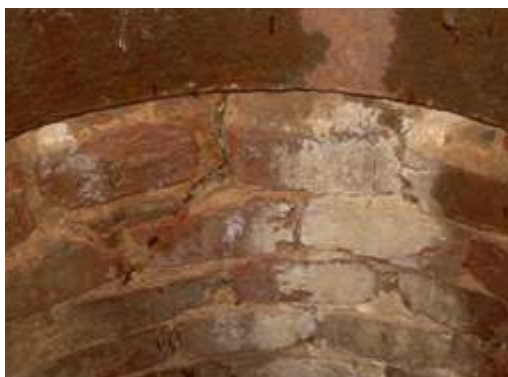
Defect

Frame leaks. Adjustment deterioration and infiltration.

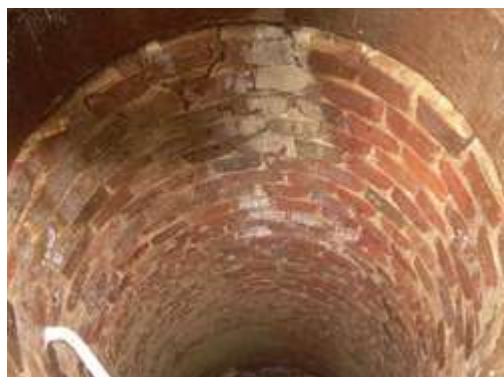
Defect

Frame leaks. Adjustment deterioration and infiltration. Corbel and Barrel infiltration.

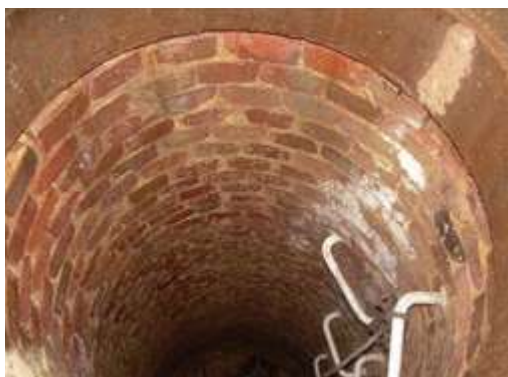
Defect

Frame leaks. Adjustment deterioration and infiltration. Corbel and Barrel infiltration - other side.

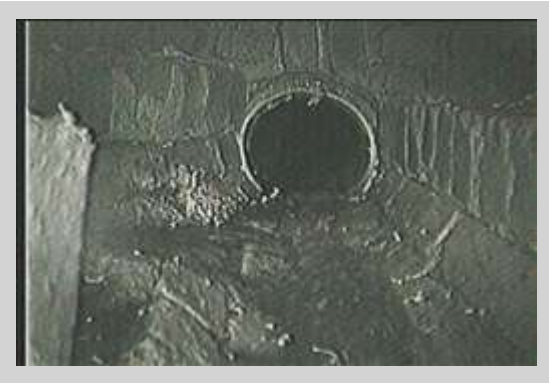
8 in. Circular Gravity Sewer Pipe Out @ 12 O'Clock

Infiltration: **Evidence** Pipe Seal Cond: **Roots**

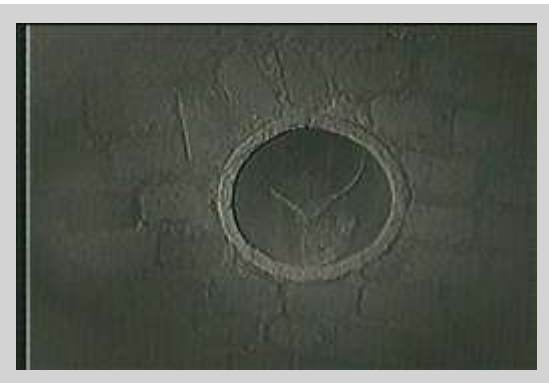
8 in. Circular Gravity Sewer Pipe In @ 6 O'Clock

Infiltration: **Evidence** Pipe Seal Cond: **Unknown**

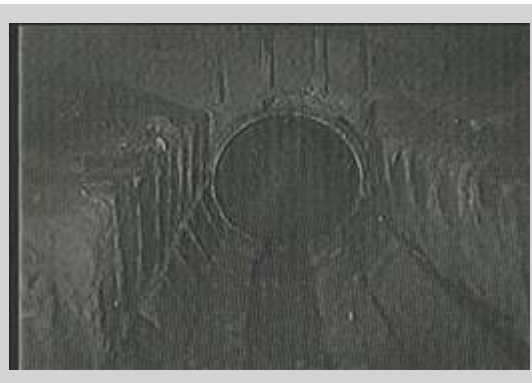
Drop In @ 6 O'Clock

Channel deterioration.

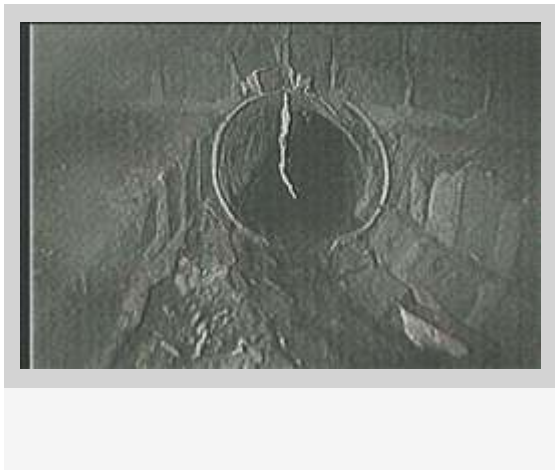
8 in. Circular Gravity Sewer
Pipe In @ 9 O'Clock

Infiltration: **Evidence** Pipe Seal Cond: **Roots**
